# Manhole Inspection Summary

Manhole # S51E\_\_018MH

Insp Date: **5/13/08 9:59 AM**

**Location** Address: **1 n streeper st**

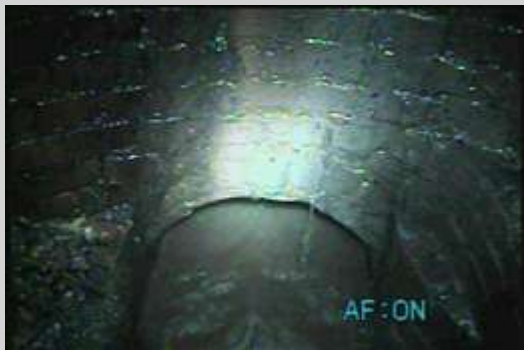
12 O'Clock Outflow

18 in. Circular Gravity Sewer  
Pipe Out @ 12 O'Clock

Pipe Material: **Clay** ☐ Pipe Lined

Invert Depth: 17.07 (ft.) Flow Characteristics: **Fast**

Deposits: ☒ None ☐ Mud ☐ Sludge ☐ Debris ☐ Grease

Infiltration: **None** Pipe Seal Cond: **Unknown**

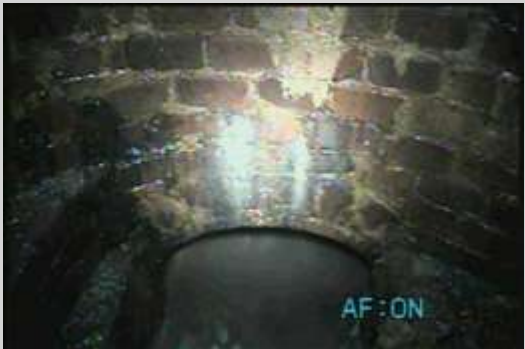
6 O'Clock Inflow

18 in. Circular Gravity Sewer  
Pipe In @ 6 OClock

Pipe Height: 0 (in.) Direct  
Pipe Material: Clay ☐ Pipe Lined  
Invert Depth: 17.00 (ft.) Flow Characteristics: Fast  
Deposits: ☒ None ☐ Mud ☐ Sludge ☐ Debris ☐ Grease  
Silt Depth: 0 (in.) Deposits Extent:  
Infiltration: None Pipe Seal Cond: Unknown
